## TURNKEY FAN REPAIR & INSTALLATION

### PROJECT OVERVIEW

**APPLICATION**  
Induced Draft Fan

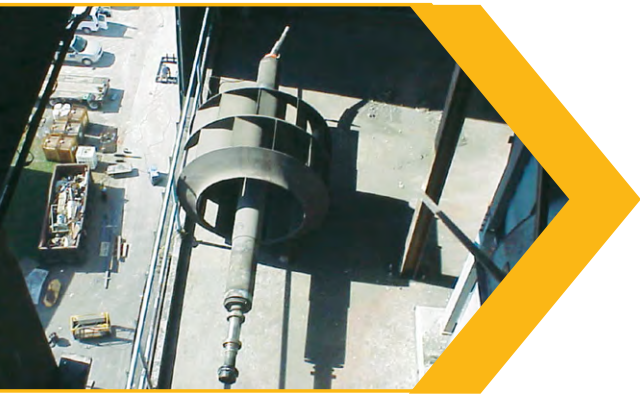
The power plant recently experienced a major equipment failure. When the motor bearings seized on the induced draft (ID) fan for the facility's boiler, the resulting fan rotor inertia destroyed the ID fan's shaft and bearings, and damaged the impeller and dampers.

BENT SHAFT & ROTOR  
(FAN LOCATION 120 FEET ABOVE GROUND)

While the damaged impeller was in transit to the Clarage facility, the Clarage team machined a new shaft from stock shaft material. Clarage takes great pride in maintaining a large inventory of shaft materials, bearings, and many other critical fan components – all in a wide range of sizes. For this repair, Clarage used Dodge 4.4375-inch RTL SLEEVOIL bearings, which were available in inventory. Because of Clarage's extensive inventory, lead time for the shaft and bearings was reduced from months to days.

Clarage finished machining the shaft as the equipment arrived at the plant. The team removed the old shaft, placed the new shaft in the impeller, and balanced and painted the rotor. Clarage also fabricated two heavy-duty inlet dampers – in only three days – and shipped the repaired equipment back to the power plant.

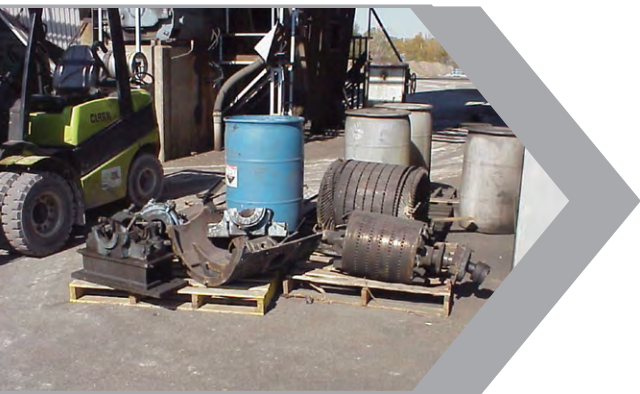
DESTROYED MOTOR & BEARINGS  
(EXISTING FAN)

The power plant turned to Clarage for a solution. Field crews were dispatched immediately. They extracted the rotor and shipped it to the Clarage facility for repair. Clarage repaired the impeller and dampers, and supplied new bearings, which the field crew quickly installed.
