# CASE STUDY

## REPLACEMENT WASTE GAS FANS

## IRON ORE MINING

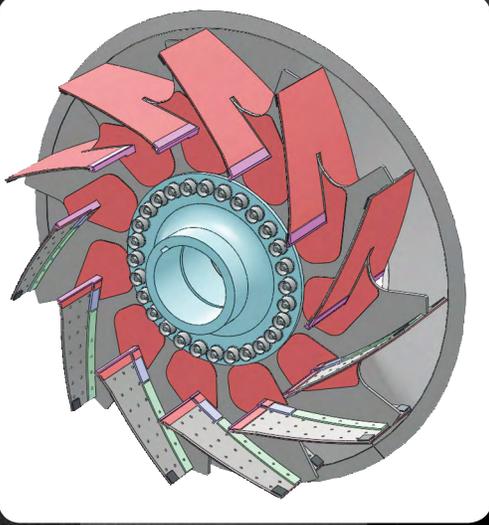
**Backward Curved Impeller with Chromium Carbide Overlayment**

Clarage provided four backward curved rotors and their housings. The rotors and housings were lined with chromium carbide to help prevent erosion. Chromium carbide is a strong material that successfully handles sliding abrasion versus impingement abrasion.

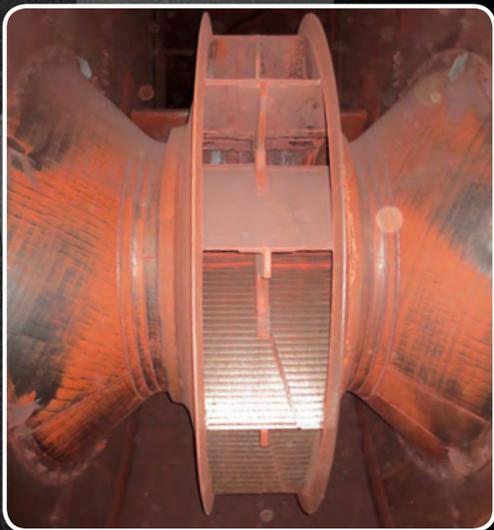
**Clarage's New Impeller After 18 Months of Operation with no wear**

Because of the smaller impeller, the fan system is more efficient, and, therefore consumes less energy. The wider damper opening reduces housing vibrations. And the chromium carbide on the impellers and housings reduce blade wear.
