## Fan Bearing Maintenance & Troubleshooting

## Bearing Failures and Their Causes

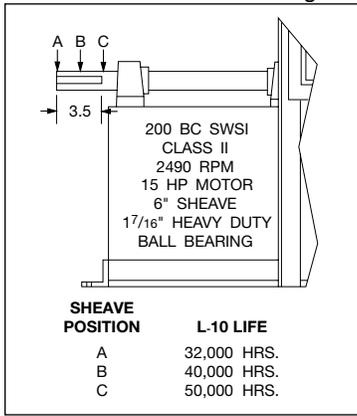
Figure 1. Effect of Sheave Location on Bearing Life

Figure 1 shows a typical fan selected to use a sheave with a six inch diameter on the fan shaft. With the sheave mounted at the end of the shaft, as far away from the bearing as possible, the L-10 life calculates to be 32,000 hours. (See FE-1200 for an explanation of L-10 life.) By moving the sheave 1.25" closer to the bearing, the life is increased to 40,000 hours. When the sheave is moved in another 1.25" so that it is as close to the bearing as possible, the life increases to 50,000 hours. The lesson learned by this example is to maximize bearing life by mounting the sheave as close to the bearing as possible.

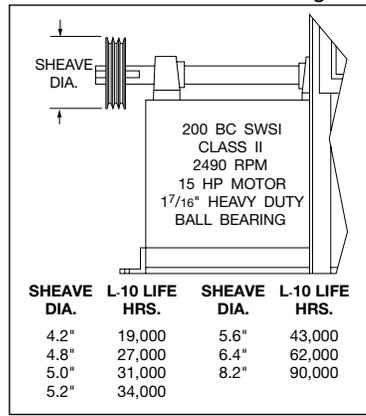
Figure 2. Effect of Sheave Diameter on Bearing Life

Most belt drives are selected using computer programs. The user puts in the information and the computer selects several sheave and belt combinations that will work, and usually highlights the least expensive. But the combination selected has a significant effect on bearing life. Large sheaves result in less belt pull and longer bearing life. Figure 2 shows the L-10 life for different fan sheave diameters. All of them are viable drive selections. The L-10 life varies from 19,000 hours with a 4.2 inch diameter sheave, to 90,000 hours with an 8.2 inch diameter sheave. Avoid the selections with the smallest sheave sizes. They are probably not the least expensive anyway since they require more belts. The best drive selection is one with a reasonable sheave size and moderate cost.

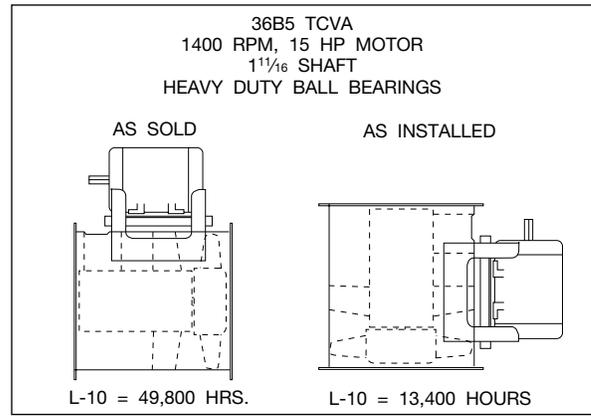
Figure 3. Effect of Shaft Position on Bearing Life

Fan orientation affects bearing life. A fan designed to operate with its shaft positioned horizontally will have a lower bearing life when positioned with a vertical shaft. This is due to the additional thrust loads put on the bearings from the shaft and impeller weight. Figure 3 shows an example. An axial fan designed for horizontal duty has an L-10 life of 49,800 hours. Tipping the fan so that the shaft is vertical lowers the bearing life to an unacceptable level of 13,400 hours. If a fan is to operate with a vertical shaft, make sure to order it for this orientation.

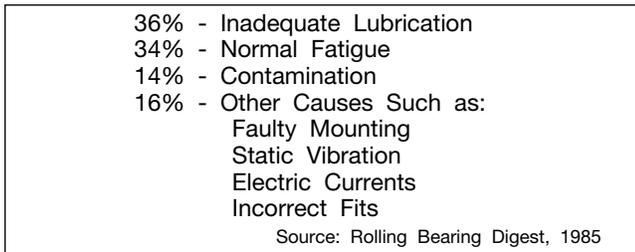
Figure 4. Bearing Failure Causes

The L-10 life discussed earlier is an estimate of the fatigue life of a bearing. However, there are many other factors that determine how long a bearing lasts. Figure 4 shows the results of one study that looked at the reasons for bearing failure. What is interesting about this study is that it shows that normal fatigue is not the normal cause of bearing failure, since only 34% of the bearings failed this way. Half of the bearing failures were due to either inadequate lubrication or contamination. Other sources list fatigue to be the cause of only 10% of bearing failures.

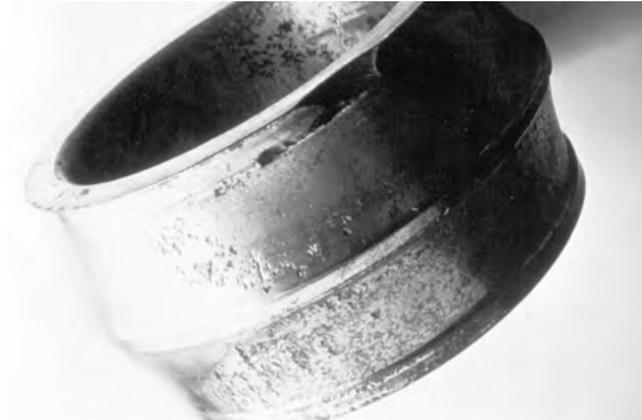
Figure 5. Normal Fatigue Failure

Figure 5 shows an inner race that has had a normal fatigue failure. The repeated loading and unloading of the race every time a roller passes eventually causes microscopic fatigue cracks to form under the surface.

In time, these cracks grow to the point where small portions of the surface flake off. This process is called "spalling" and the flaws left in the surface are called "spalls."

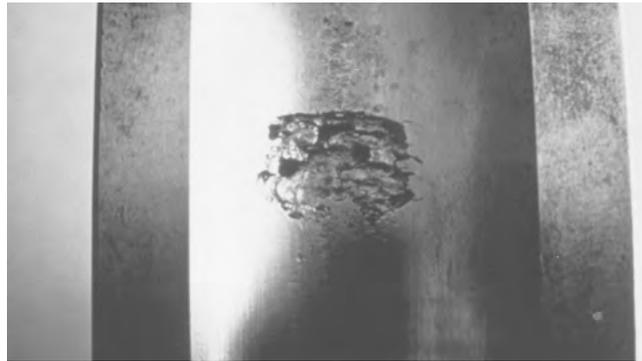
Figure 6. Spall

With continued operation, the spalls grow until the bearing becomes noticeably noisy. Figure 6 shows an inner race that has a severe spall. In addition to being noisy, it is also likely that this bearing would show high levels of vibration. The time required for the spalling to cause catastrophic bearing failure will vary with the load on the bearing and its speed. Usually the bearing will run for a while after it becomes noisy, but once noise is heard, prepare to have the bearing changed before it fails suddenly.

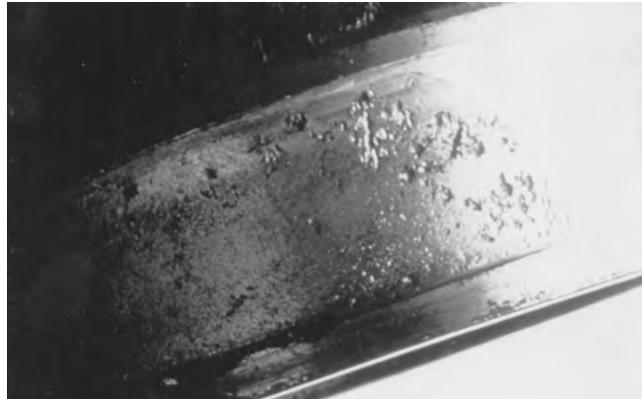
Figure 7. Spalls & Wear Patterns in the Race

Inadequate lubrication can lead to spalling as seen in Figure 7. This bearing also shows signs of excessive

wear due to inadequate lubrication. The rollers have worn a very deep wear pattern in the race.

Material that flakes out of spalls and other contaminants from other sources such as dirty grease or worn seals dents the races when caught between the rollers and races. Figure 13 shows an inner race with severe particle denting. Figure 7 also shows signs of particle denting. Each dent is a stress concentrator, which increases the stress in the area around the dent and accelerates the fatigue failure process.

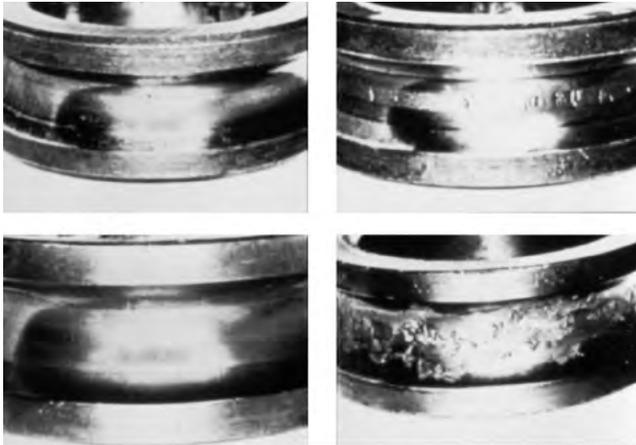
Figure 8. Progressive Failure of a Bearing Due to Inadequate Lubrication

Figure 8 shows the progressive failure of a bearing due to inadequate lubrication. At first there are traces of waviness, or a slight roughening of the race. With time small cracks develop, which lead to a modest amount of spalls and eventually the severe amount of spalling shown on the lower right.

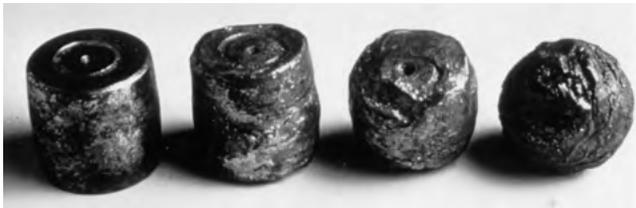
Figure 9. Damaged Spherical Bearing Rollers

If the bearings continue to operate with inadequate lubrication, the evidence that shows this to be the mode of failure becomes destroyed. Notice how the spherical bearing rollers shown in Figure 9 become damaged with continued operation.

If the bearing had been taken out of operation when the roller was in the condition shown on the left, it would be possible to determine the cause of failure. By the time the bearing completely failed, it had run so hot that the steel softened and the bearing became deformed. At this point it is impossible to tell what caused the initial failure. If you are having unexplained bearing failures, it is best to take the bearing out of service when you first notice noisy, hot, or vibrating operation. The evidence showing the initial cause of failure is probably still visible and it will give you an idea as to what action to take to prevent additional failures.

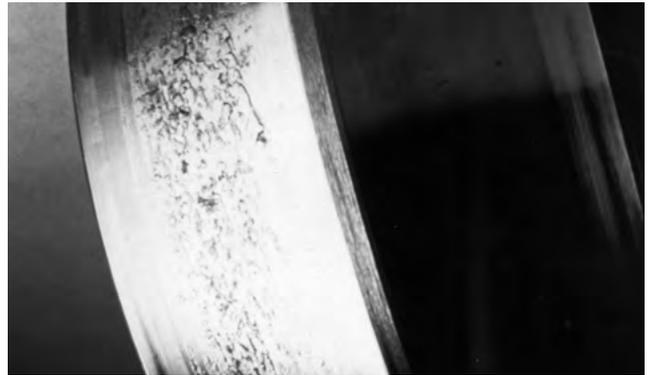
Figure 10. Smearing

Under the right conditions the heat generated by metal-to-metal contact causes the two surfaces to adhere for an instant. Small portions tear out from one surface and adhere to the other surface. This is “smearing” and is shown in Figure 10.

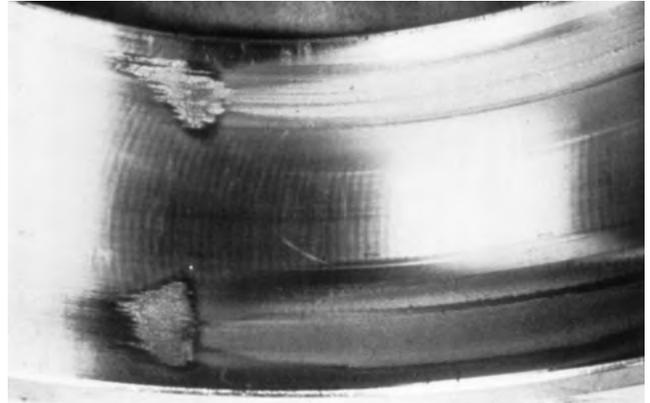
Figure 11. Skid Smearing

“Skid smearing,” shown in Figure 11, occurs on lightly loaded bearings. As the rollers come around and enter the lower half of the bearing, they go from being

unloaded to being under load. With the light load it takes them some distance to roll properly, and they skid against the race causing smearing.

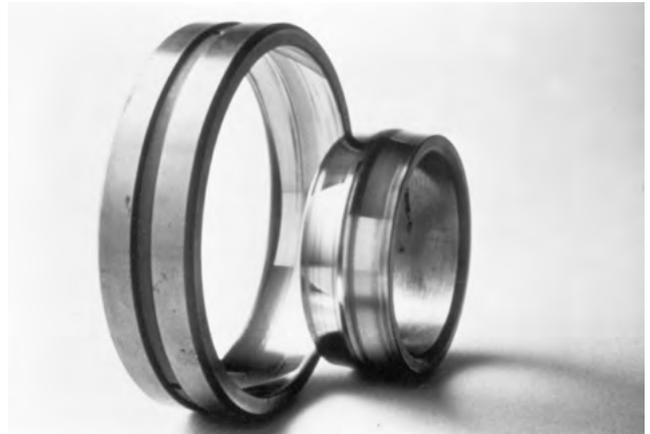
Figure 12. Highly Polished Surfaces Due to Inadequate Lubrication

Inadequate lubrication can sometimes cause the bearing surfaces to become highly polished as Figure 12 shows. Even though the surface looks nice, this is an indication of trouble. With continued operation the surface will change to a frosty appearance and eventually spall.

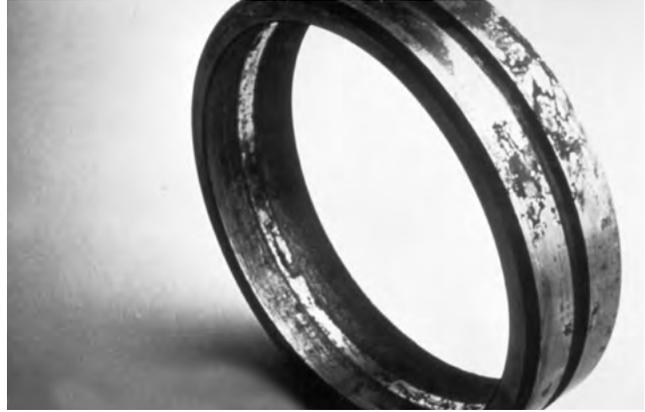
Figure 14. Water Corrosion

Keeping moisture out of bearings is necessary to achieve long life. Figure 14 shows a bearing severely damaged from water corrosion. This much damage was

probably due to seal failure, possibly in a “wash down” environment. High moisture applications require the use of grease that has rust inhibiting properties. Frequent relubrication is necessary, to insure that all bearing surfaces are coated with a protective layer of grease and that the rust inhibitors are replenished. Figure 15 shows a spherical roller bearing roller that has rusty ends from moisture in the lubricant.

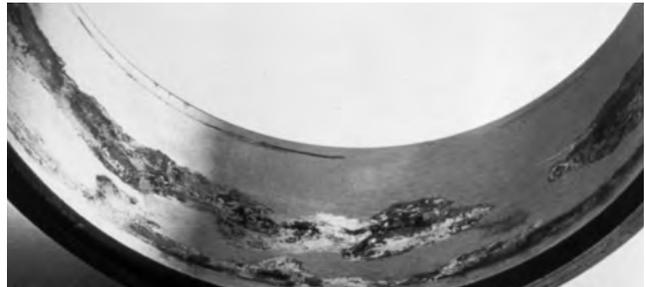
Figure 16. Puddle Corrosion

Water from condensation causes corrosion in idle fans. This is particularly true for fans in high moisture areas, located outdoors, or improperly stored outdoors. Figure 16 shows an outer race damaged by puddle corrosion. Moisture or dew condensing in the bearing settles to the bottom of the race in puddles and causes rusting. Twin City Fan Companies packs ball and unit roller bearings completely full of grease prior to shipment. Split pillow block spherical roller bearings are shipped with the bearing insert packed full. This minimizes the chances of having puddle corrosion occur during shipment and storage. This practice covers all components with grease and insures there are no pockets of air where water can condense. At startup the excess grease purges out of the bearing, which gets a little messy but is better than having a damaged bearing.

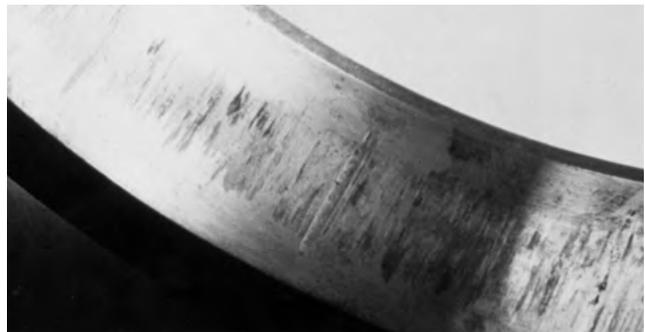
Figure 17. False Brinnelling

Figure 17 shows damage to an outer race from a bearing subjected to vibration while the unit is not rotating. Notice the even spacing of the marks, which correspond to the roller spacing. You can also see marks where the rollers came to rest in different locations. This type of damage, called “false brinnelling,” occurs when small portions of the race get rubbed away. The remaining area is ideal for starting fatigue and the abrasive material rubbed off contaminates the grease which accelerates bearing wear.

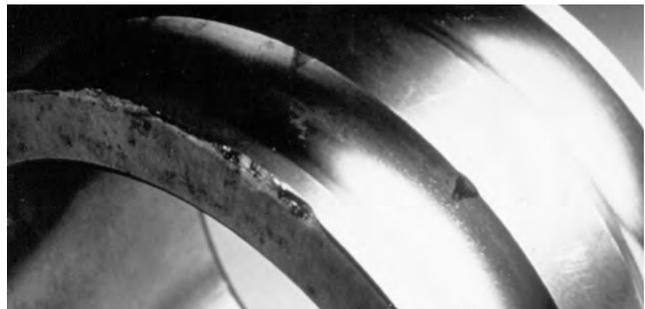
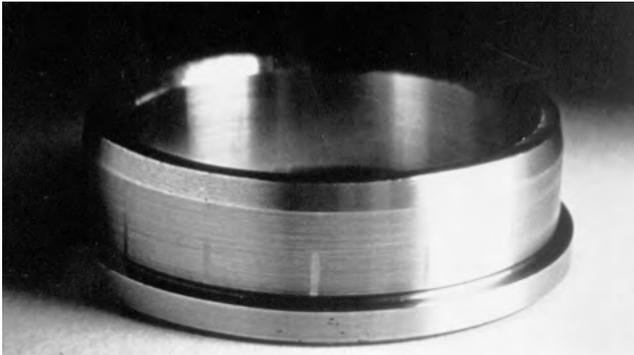
“True brinnelling” occurs when a bearing is subjected to impact and the rollers dent the races. Figures 18 and 19 show damage caused by improper mounting. Impact from hammering on the outer race or the bearing housing causes true brinnelling of the races. If it is necessary to tap on a bearing to get it into position, tap on the inner race so that the rolling elements do not carry the load. Dropping a bearing prior to mounting can also cause true brinnelling. Like false brinnelling, the marks are evenly spaced and the damage will eventually develop into spalls. Figure 20 shows spalls resulting from true brinnelling.

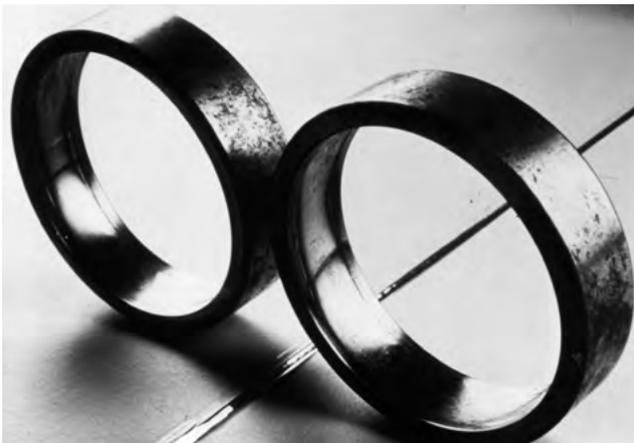
Figure 21. Two Load Zones on the Outer Race

Mounting a bearing pillow block on a warped or crowned surface, or improperly shimming a pillow block can pinch the outer race. As seen in Figure 21, this causes two load zones on the outer race 180° apart.

As the rolling elements pass through the pinched area, the load between them and the races increases. If the severity of the pinch is high, a drastic reduction in the life of the bearing will result.

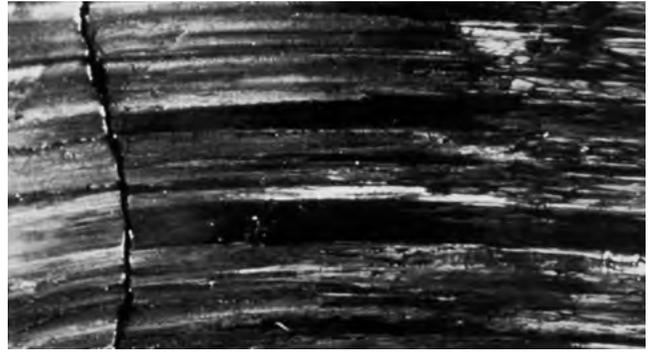
Figure 22. Smearing on a Bearing Race

failures. Figure 22 shows the surface of a bearing bore that had too much clearance. The shaft turned in the bore, smearing the surface.

Insufficient tightening of the setscrews on a setscrew mounted bearing causes this type of failure. It can also be caused on a tapered adapter mounted bearing by not tightening the adapter lock nut enough. The damage to the surface resulted in a crack.

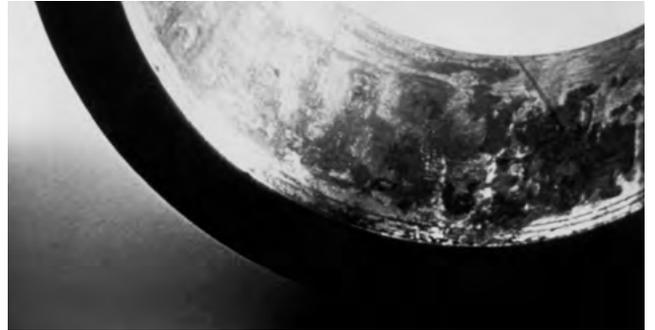
Figure 23. Fretting Corrosion on Bearing Bore

The bore of the bearing shown in Figure 23 shows signs of serious fretting corrosion. Microscopic movement between the shaft and the bore causes the rust colored patches to develop. Small amounts of fretting are common with setscrew mounted bearings and are not detrimental to bearing life. Advanced cases, caused by loose mounting, can lead to cracks.

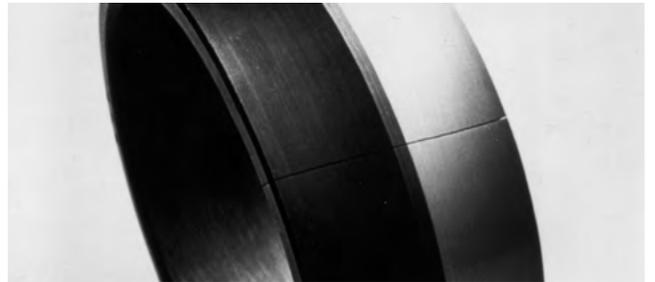
Figure 24. Cracked Inner Race

Tightening the locknut of an adapter mounted bearing too much can crack the inner race as shown in Figure 24, or the outer race as shown in Figure 25.

This also occurs by exposing the bearing on a high temperature fan to excessive temperatures. This easily happens when shutting down high temperature fans when they are hot, or by exposing them to high temperatures while idle.

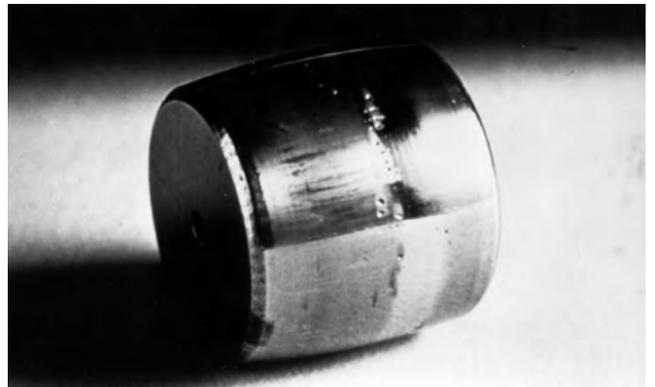
Figure 26. Pits Caused by Electrical Current

Allowing electrical current to pass through a bearing can cause damage. Figure 26 shows a spherical roller with pits in its surface caused by electrical current. This type of damage commonly occurs when welding balance weights on a fan wheel with improper grounding. To avoid having the welding electrical current pass through the bearings, attach the grounding clamp to the wheel or shaft when adding balance weights.
