Fan Bearing Maintenance & Troubleshooting

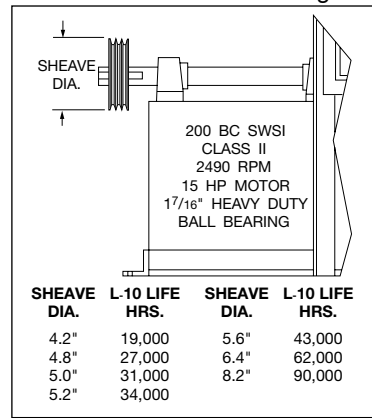
Most belt drives are selected using computer programs. The user puts in the information and the computer selects several sheave and belt combinations that will work, and usually highlights the least expensive. But the combination selected has a significant effect on bearing life. Large sheaves result in less belt pull and longer bearing life. Figure 2 shows the L-10 life for different fan sheave diameters. All of them are viable drive selections. The L-10 life varies from 19,000 hours with a 4.2 inch diameter sheave, to 90,000 hours with an 8.2 inch diameter sheave. Avoid the selections with the smallest sheave sizes. They are probably not the least expensive anyway since they require more belts. The best drive selection is one with a reasonable sheave size and moderate cost.

Figure 2. Effect of Sheave Diameter on Bearing Life

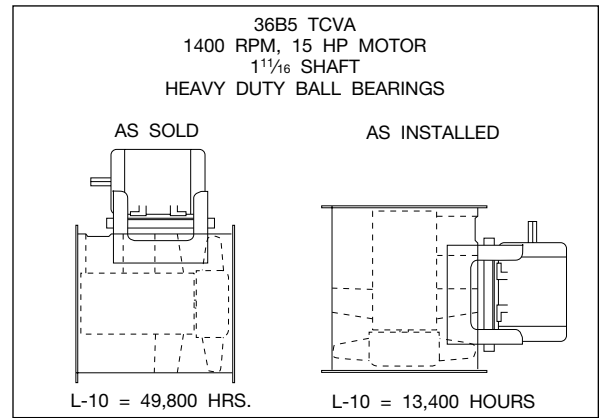
Fan orientation affects bearing life. A fan designed to operate with its shaft positioned horizontally will have a lower bearing life when positioned with a vertical shaft. This is due to the additional thrust loads put on the bearings from the shaft and impeller weight. Figure 3 shows an example. An axial fan designed for horizontal duty has an L-10 life of 49,800 hours. Tipping the fan so that the shaft is vertical lowers the bearing life to an unacceptable level of 13,400 hours. If a fan is to operate with a vertical shaft, make sure to order it for this orientation.

Figure 3. Effect of Shaft Position on Bearing Life

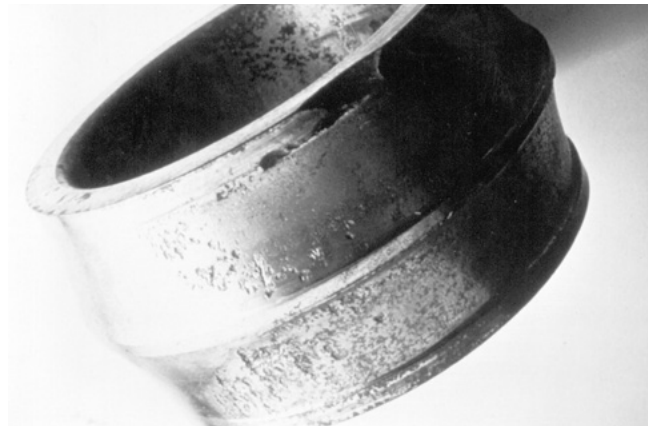
Figure 5 shows an inner race that has had a normal fatigue failure. The repeated loading and unloading of the race every time a roller passes eventually causes microscopic fatigue cracks to form under the surface.

In time, these cracks grow to the point where small portions of the surface flake off. This process is called "spalling" and the flaws left in the surface are called "spalls."

Figure 5. Normal Fatigue Failure

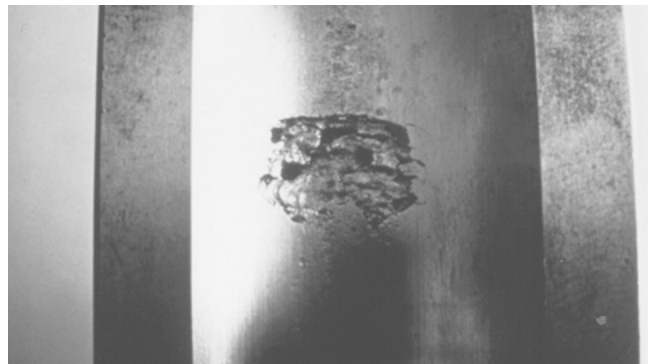
With continued operation, the spalls grow until the bearing becomes noticeably noisy. Figure 6 shows an inner race that has a severe spall. In addition to being noisy, it is also likely that this bearing would show high levels of vibration. The time required for the spalling to cause catastrophic bearing failure will vary with the load on the bearing and its speed. Usually the bearing will run for a while after it becomes noisy, but once noise is heard, prepare to have the bearing changed before it fails suddenly.

Figure 6. Spall

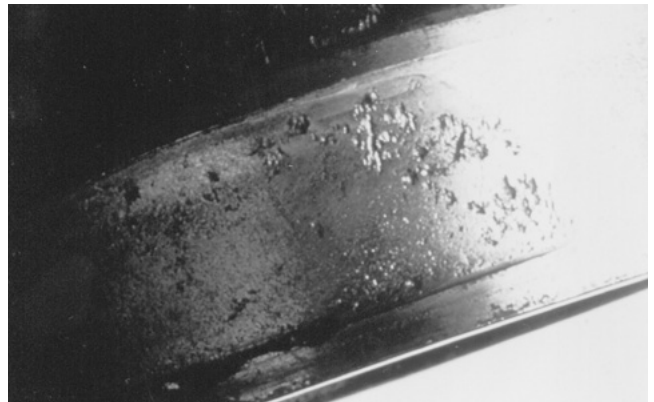
Inadequate lubrication can lead to spalling as seen in Figure 7. This bearing also shows signs of excessive

Figure 7. Spalls & Wear Patterns in the Race

wear due to inadequate lubrication. The rollers have worn a very deep wear pattern in the race.

Material that flakes out of spalls and other contaminants from other sources such as dirty grease or worn seals dents the races when caught between the rollers and races. Figure 13 shows an inner race with severe particle denting. Figure 7 also shows signs of particle denting. Each dent is a stress concentrator, which increases the stress in the area around the dent and accelerates the fatigue failure process.

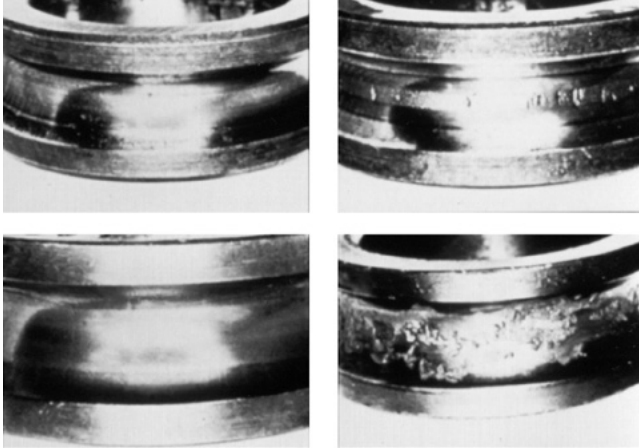
Figure 8 shows the progressive failure of a bearing due to inadequate lubrication. At first there are traces of waviness, or a slight roughening of the race. With time small cracks develop, which lead to a modest amount of spalls and eventually the severe amount of spalling shown on the lower right.

Figure 8. Progressive Failure of a Bearing Due to Inadequate Lubrication

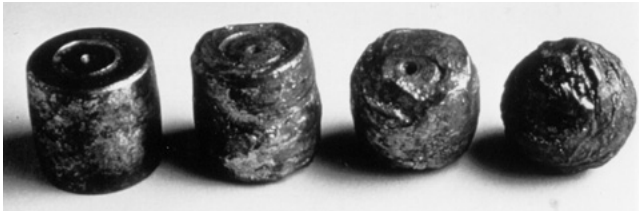
If the bearings continue to operate with inadequate lubrication, the evidence that shows this to be the mode of failure becomes destroyed. Notice how the spherical bearing rollers shown in Figure 9 become damaged with continued operation.

Figure 9. Damaged Spherical Bearing Rollers

If the bearing had been taken out of operation when the roller was in the condition shown on the left, it would be possible to determine the cause of failure. By the time the bearing completely failed, it had run so hot that the steel softened and the bearing became deformed. At this point it is impossible to tell what caused the initial failure. If you are having unexplained bearing failures, it is best to take the bearing out of service when you first notice noisy, hot, or vibrating operation. The evidence showing the initial cause of failure is probably still visible, and it will give you an idea as to what action to take to prevent additional failures.

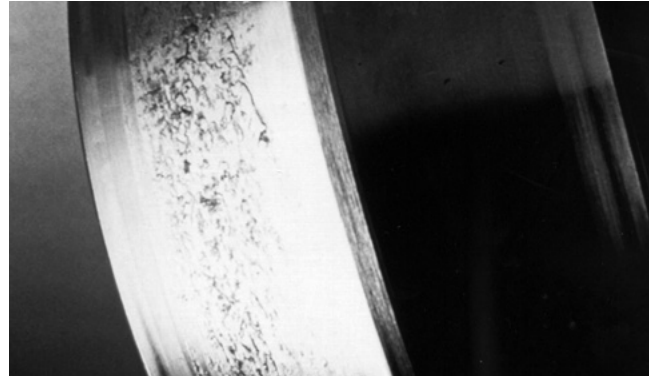
Under the right conditions the heat generated by metal-to-metal contact causes the two surfaces to adhere for an instant. Small portions tear out from one surface and adhere to the other surface. This is "smearing" and is shown in Figure 10.

Figure 10. Smearing

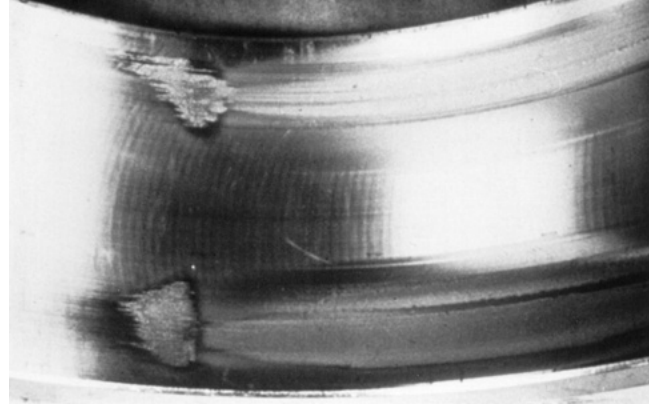
"Skid smearing," shown in Figure 11, occurs on lightly loaded bearings. As the rollers come around and enter the lower half of the bearing, they go from being

Figure 11. Skid Smearing

unloaded to being under load. With the light load it takes them some distance to roll properly, and they skid against the race causing smearing.

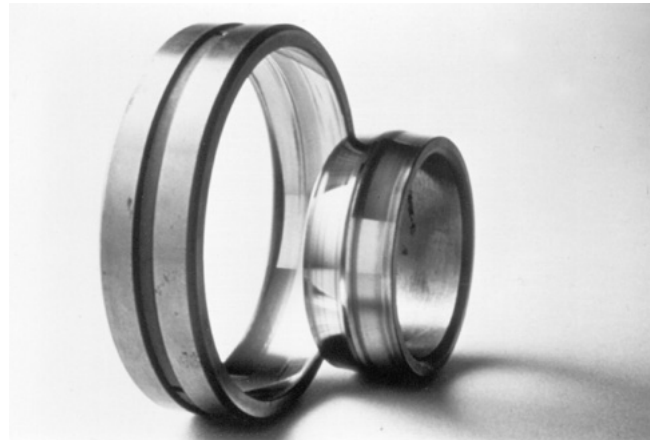
Figure 12. Highly Polished Surfaces Due to Inadequate Lubrication

Inadequate lubrication can sometimes cause the bearing surfaces to become highly polished as Figure 12 shows. Even though the surface looks nice, this is an indication of trouble. With continued operation the surface will change to a frosty appearance and eventually spall.

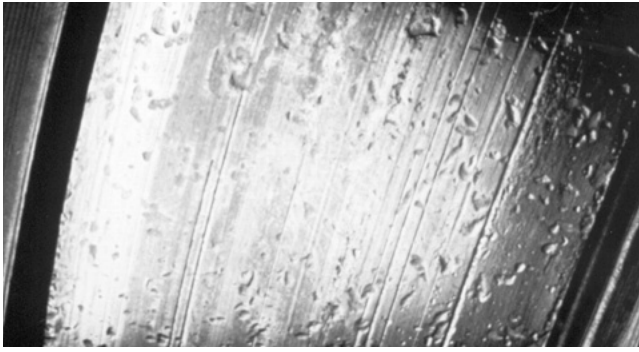
Figure 13. Severe Particle Denting

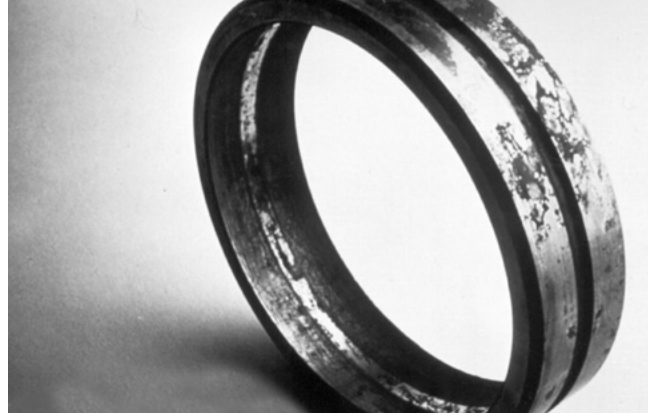
Keeping moisture out of bearings is necessary to achieve long life. Figure 14 shows a bearing severely damaged from water corrosion. This much damage was

probably due to seal failure, possibly in a “wash down” environment. High moisture applications require the use of grease that has rust inhibiting properties. Frequent relubrication is necessary, to insure that all bearing surfaces are coated with a protective layer of grease and that the rust inhibitors are replenished. Figure 15 shows a spherical roller bearing roller that has rusty ends from moisture in the lubricant.

Figure 14. Water Corrosion

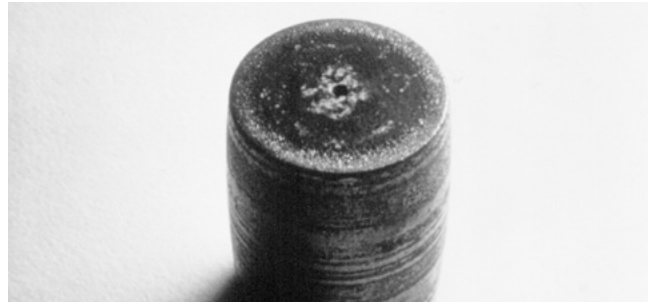
Figure 15. Bearing Roller with Rusty Ends Due to Moisture in the Lubricant

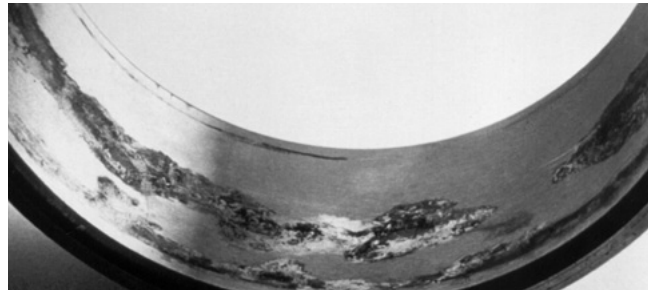
Water from condensation causes corrosion in idle fans. This is particularly true for fans in high moisture areas, located outdoors, or improperly stored outdoors. Figure 16 shows an outer race damaged by puddle corrosion. Moisture or dew condensing in the bearing settles to the bottom of the race in puddles and causes rusting. Twin City Fan Companies packs ball and unit roller bearings completely full of grease prior to shipment. Split pillow block spherical roller bearings are shipped with the bearing insert packed full. This minimizes the chances of having puddle corrosion occur during shipment and storage. This practice covers all components with grease, and insures there are no pockets of air where water can condense. At startup the excess grease purges out of the bearing, which gets a little messy but is better than having a damaged bearing.

Figure 16. Puddle Corrosion

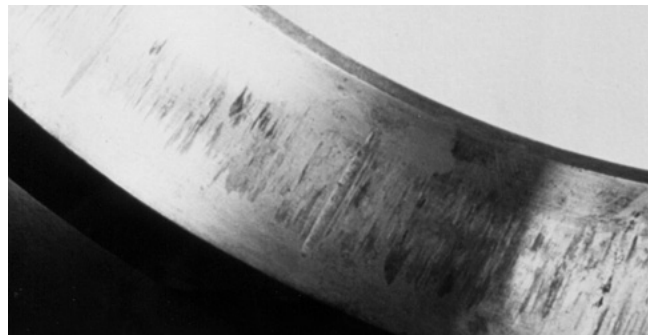
Figure 17 shows damage to an outer race from a bearing subjected to vibration while the unit is not rotating. Notice the even spacing of the marks, which correspond to the roller spacing. You can also see marks where the rollers came to rest in different locations. This type of damage, called “false brinnelling,” occurs when small portions of the race get rubbed away. The remaining area is ideal for starting fatigue, and the abrasive material rubbed off contaminates the grease which accelerates bearing wear.

Figure 17. False Brinnelling

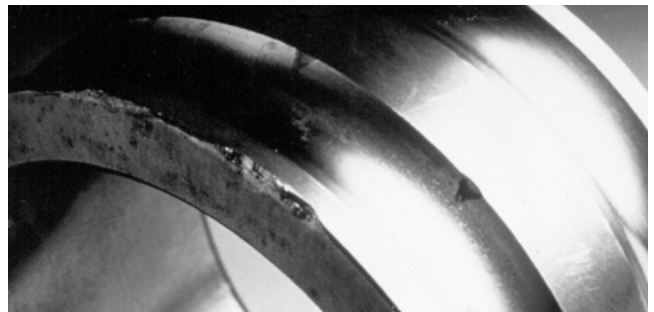
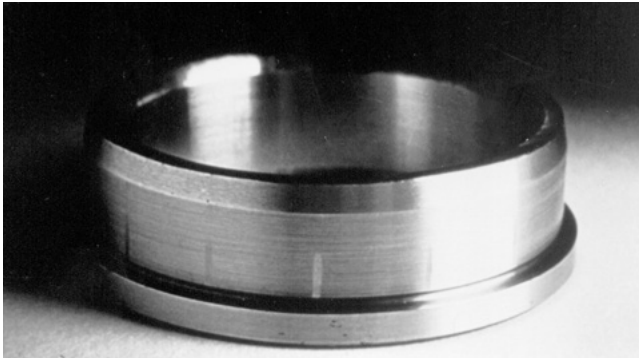
“True brinnelling” occurs when a bearing is subjected to impact and the rollers dent the races. Figures 18 and 19 show damage caused by improper mounting. Impact from hammering on the outer race or the bearing housing causes true brinnelling of the races. If it is necessary to tap on a bearing to get it into position, tap on the inner race so that the rolling elements do not carry the load. Dropping a bearing prior to mounting can also cause true brinnelling. Like false brinnelling, the marks are evenly spaced and the damage will eventually develop into spalls. Figure 20 shows spalls resulting from true brinnelling.

Figure 18. True Brinnelling

Figure 19. True Brinneling

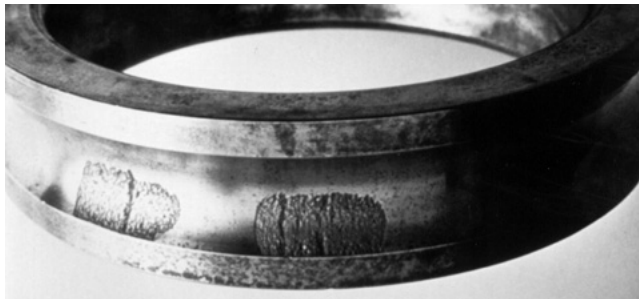
Figure 20. Spalls Resulting from True Brinneling

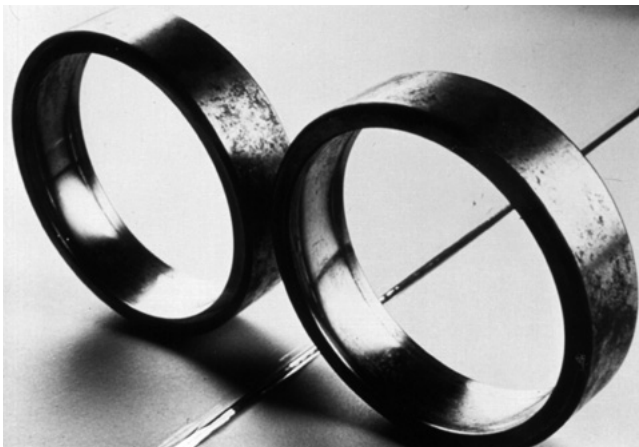
Mounting a bearing pillow block on a warped or crowned surface, or improperly shimming a pillow block can pinch the outer race. As seen in Figure 21, this causes two load zones on the outer race 180° apart.

As the rolling elements pass through the pinched area, the load between them and the races increases. If the severity of the pinch is high, a drastic reduction in the life of the bearing will result.

Figure 21. Two Load Zones on the Outer Race

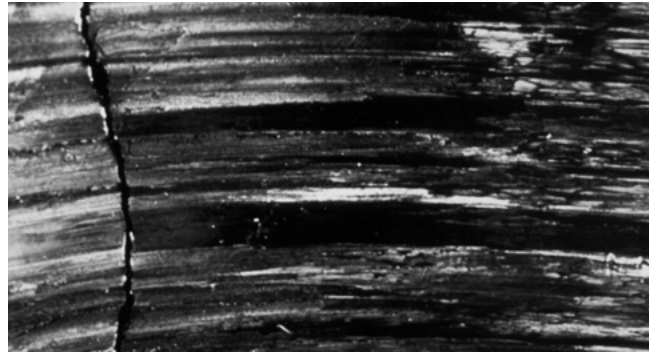
failures. Figure 22 shows the surface of a bearing bore that had too much clearance. The shaft turned in the bore, smearing the surface.

Insufficient tightening of the setscrews on a set-screw mounted bearing causes this type of failure. It can also be caused on a tapered adapter mounted bearing by not tightening the adapter lock nut enough. The damage to the surface resulted in a crack.

Figure 22. Smearing on a Bearing Race

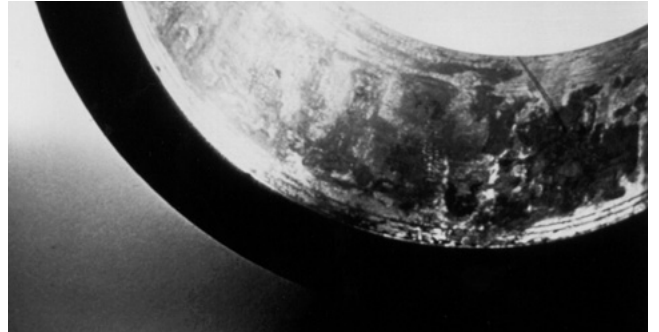
The bore of the bearing shown in Figure 23 shows signs of serious fretting corrosion. Microscopic movement between the shaft and the bore causes the rust colored patches to develop. Small amounts of fretting are common with setscrew mounted bearings and are not detrimental to bearing life. Advanced cases, caused by loose mounting, can lead to cracks.

Figure 23. Fretting Corrosion on Bearing Bore

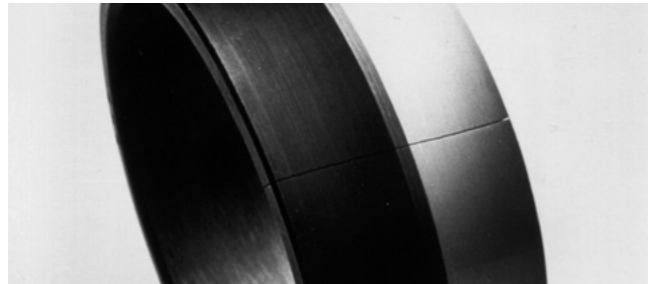
Tightening the locknut of an adapter mounted bearing too much can crack the inner race as shown in Figure 24, or the outer race as shown in Figure 25.

This also occurs by exposing the bearing on a high temperature fan to excessive temperatures. This easily happens when shutting down high temperature fans when they are hot, or by exposing them to high temperatures while idle.

Figure 24. Cracked Inner Race

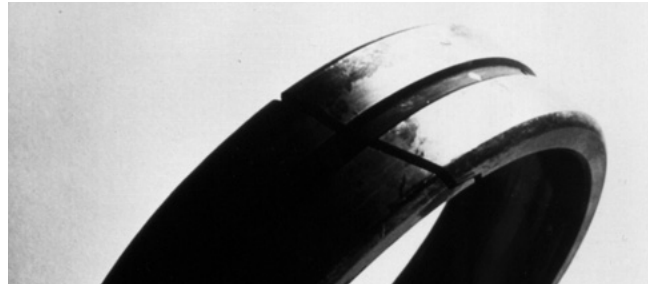
Figure 25. Cracked Outer Race

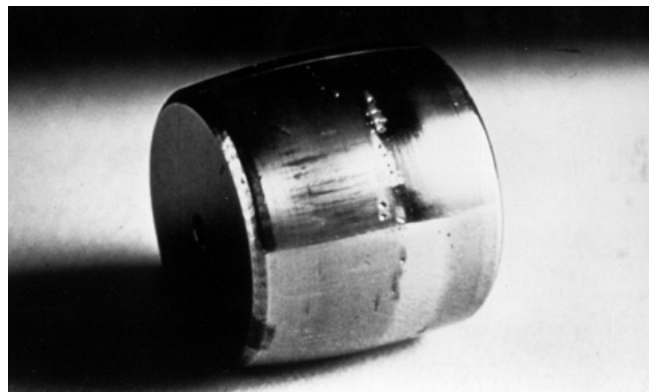
Figure 26. Pits Caused by Electrical Current

Allowing electrical current to pass through a bearing can cause damage. Figure 26 shows a spherical roller with pits in its surface caused by electrical current. This type of damage commonly occurs when welding balance weights on a fan wheel with improper grounding. To avoid having the welding electrical current pass through the bearings, attach the grounding clamp to the wheel or shaft when adding balance weights.
