## TURNKEY FAN REPAIR & INSTALLATION

### PROJECT OVERVIEW

**APPLICATION**  
Induced Draft Fan

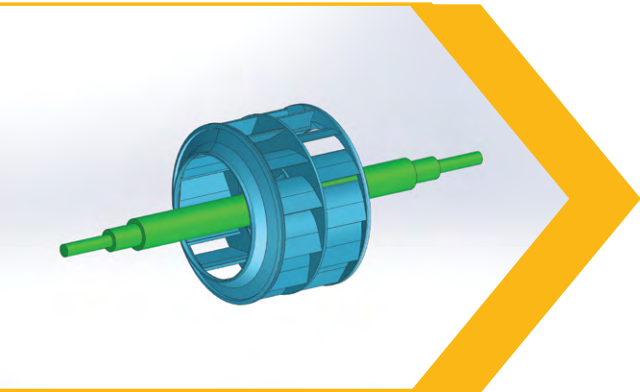
3D MODEL OF THE NEW  
ROTOR ASSEMBLY & IMPELLER

Clarage finished machining the shaft as the equipment arrived at the plant. The team removed the old shaft, placed the new shaft in the impeller, and balanced and painted the rotor. Clarage also fabricated two heavy-duty inlet dampers – in only three days – and shipped the repaired equipment back to the power plant.
